CASE HISTORY

Application: **Mining**

Technology: **RGeo-eye® Camera borehole inspection**

Location: **Ireland County Meath**

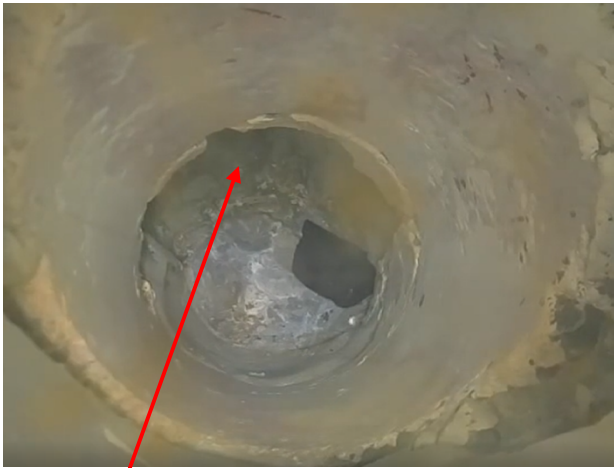
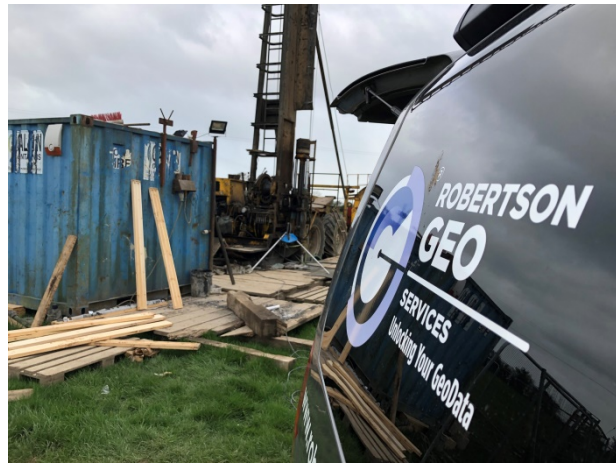
View from RGeo-eye® showing a missing section of the borehole wall.

The clarity of the camera was easily able to show a section of the borehole wall which was missing. Given this information the client was confidently able to formulate a decisive plan for the next phase of drilling.
