CASE HISTORY

Application: **Camera Inspection**

Location: **Glenfinnan Viaduct, Glenfinnan, Scotland**

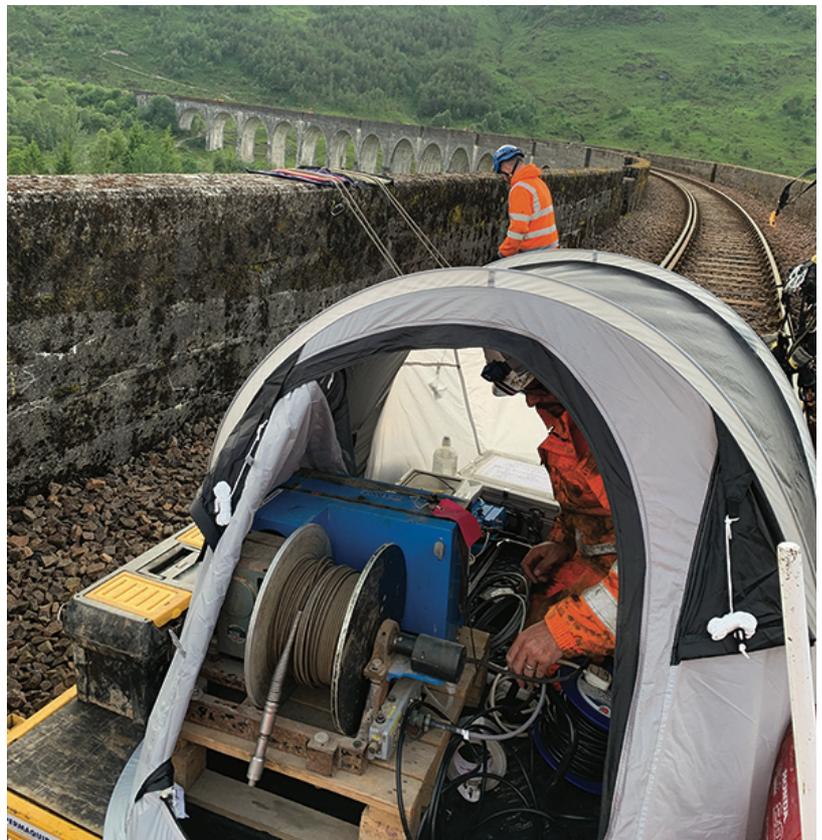
The camera deployed was an Aries Industries BT 9000 series with a bottom and rotatable side facing camera, together with a powerful integrated light source. Due to the known access issues two different surface systems were mobilised for the operation to ensure success.
